Ole 97 Bridge, a look from upstream, after work was complete. Removed a lot of the under brush to encourage erosion of the creek bank on the right side.

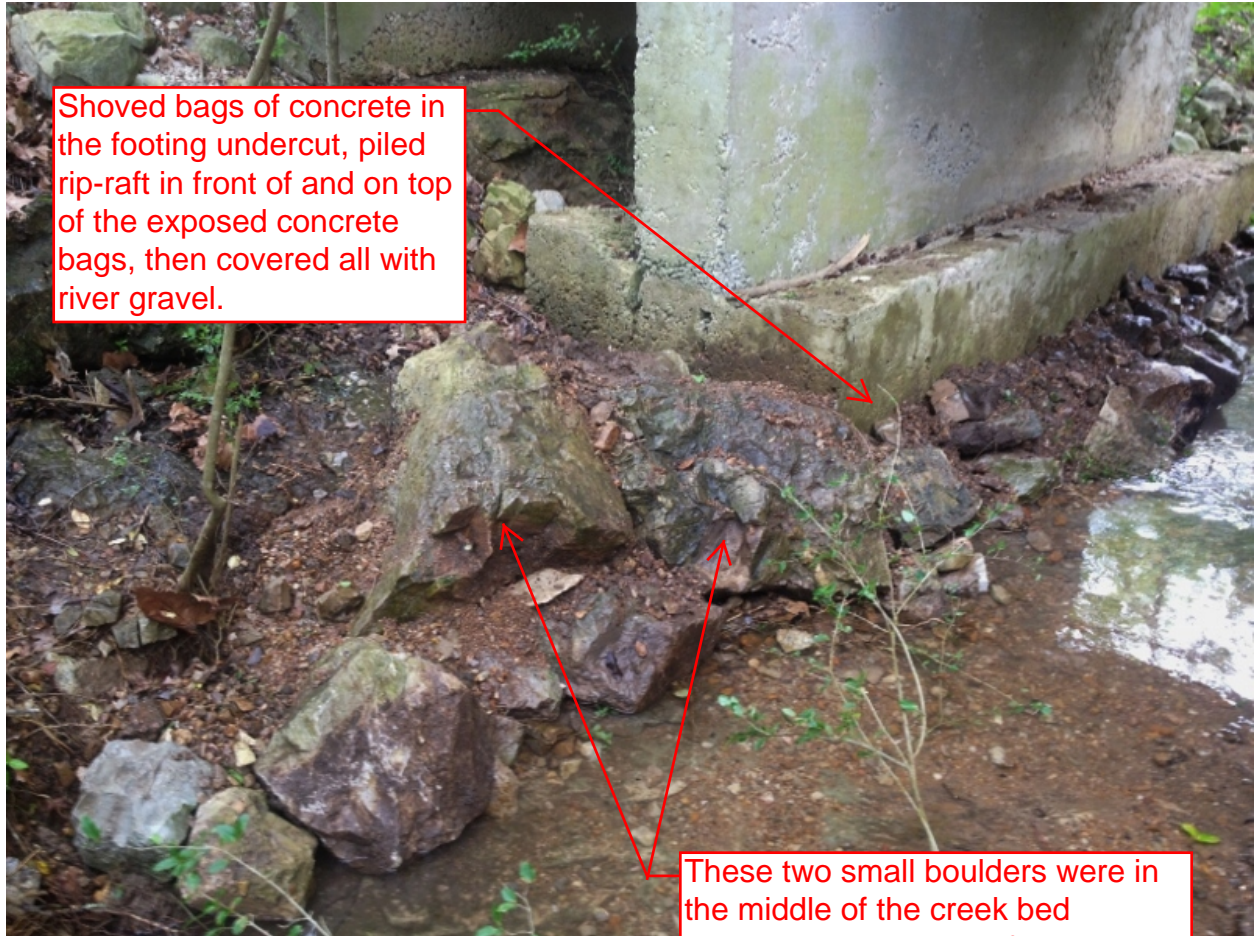
These two small boulders were in the middle of the creek bed diverting water toward footing. We moved them in front of the footing to hopefully divert water away from the footing.

Completed Work, you almost can't tell we were even there.

Shoved bags of concrete in the footing undercut, piled rip-raft in front of and on top of the exposed concrete bags, then covered all with river gravel.

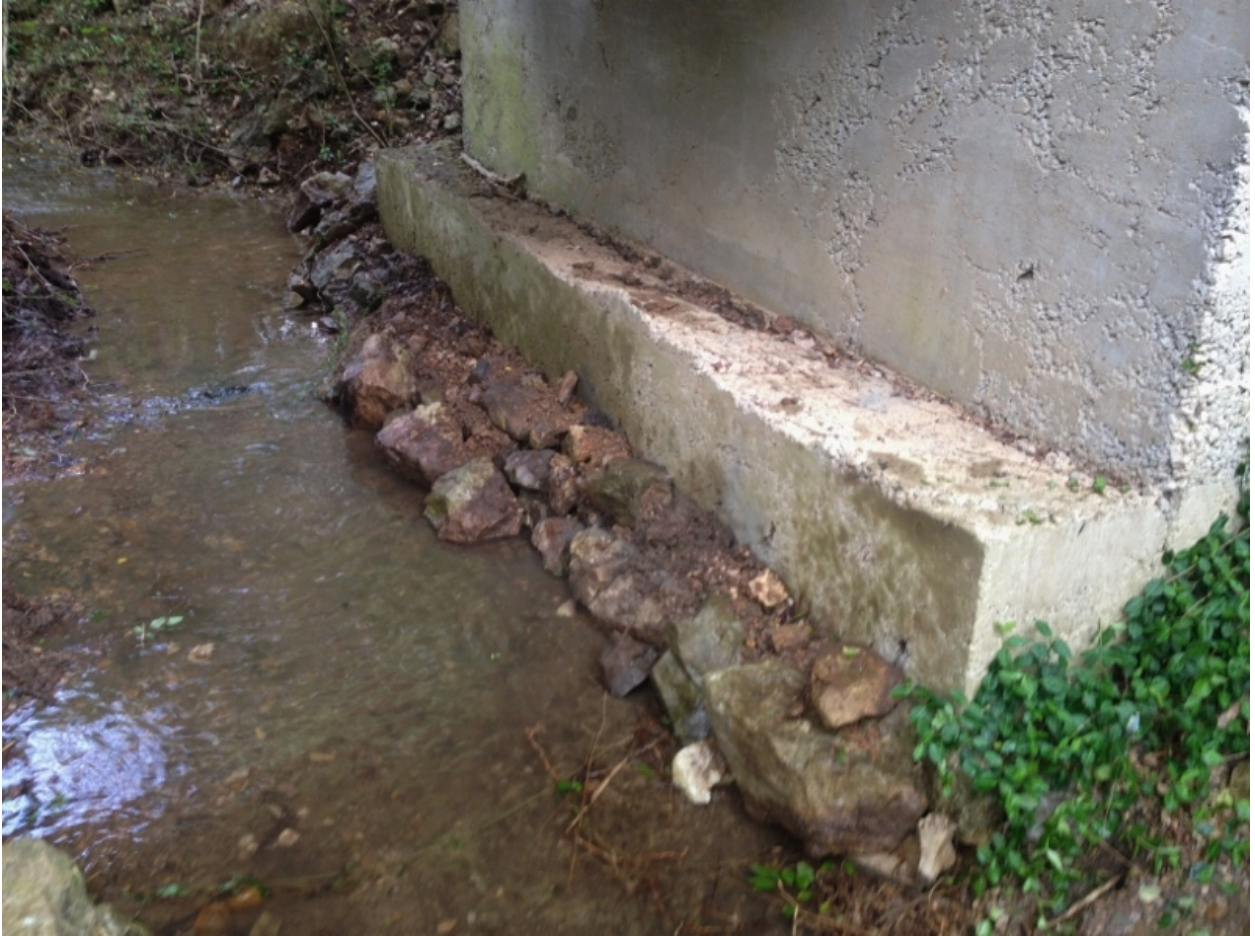
A look from the backside (downstream).
